# EMSA study

## EMSA/2024/OP/0014

### Lessons learned from passenger ship accidents

Date: 2025-03-29

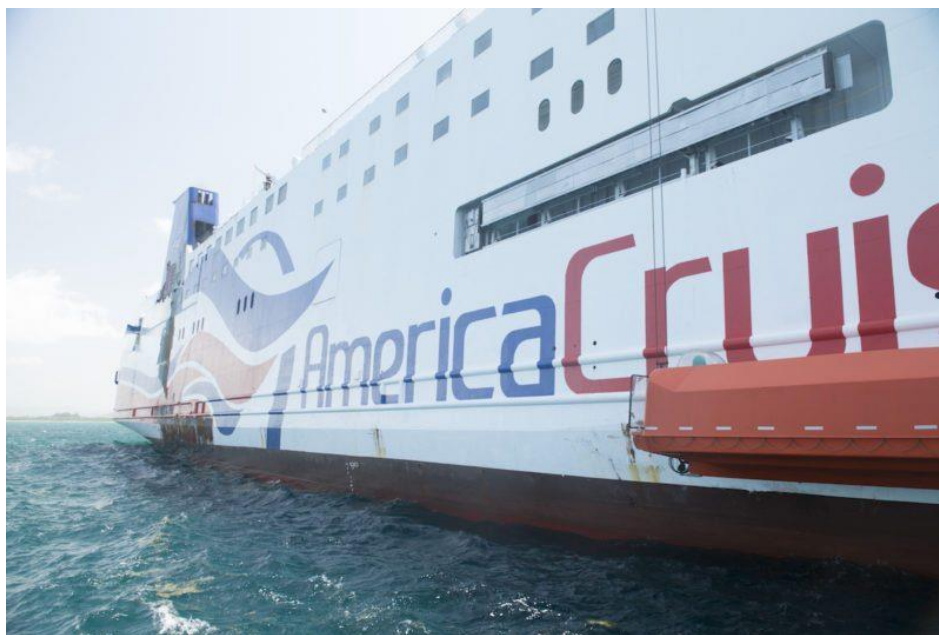
informed the Master he could not manually release the hooks, and, after all attempts to release the hooks failed, the commander reported that the boat was getting damaged from waves pushing it against the Caribbean Fantasy's side.

- About 0916, the crew hoisted lifeboat no. 3 back out of the water. During the hoist, the winch tripped off line, leaving the boat suspended about 6 feet above the water. (The prime mover for the winch was designed to lift the lifeboat with a crew of six only and not a fully loaded lifeboat.19) With the boat hanging at the ship's side and unable to be lowered, none of the Coast Guard small boats were able to be effectively positioned to remove people from the lifeboat. The Master, who was monitoring this from the starboard-side bridge wing, requested assistance from the Coast Guard ATON boat, which had a higher freeboard (nearly 6 feet). The OSC responded by directing the ATON boat to lifeboat no. 3. About 1000, the ATON boat began extracting people from the lifeboat, a process that was slowed by the height of the lifeboat and the motion of the vessels in the seas. The lifeboat commander told investigators that as the passengers were transferred to the Coast Guard vessel, he had to convince some passengers who were beginning to panic not to jump into the water.

Figure 7-2 LB3 suspended about 6 feet above the water

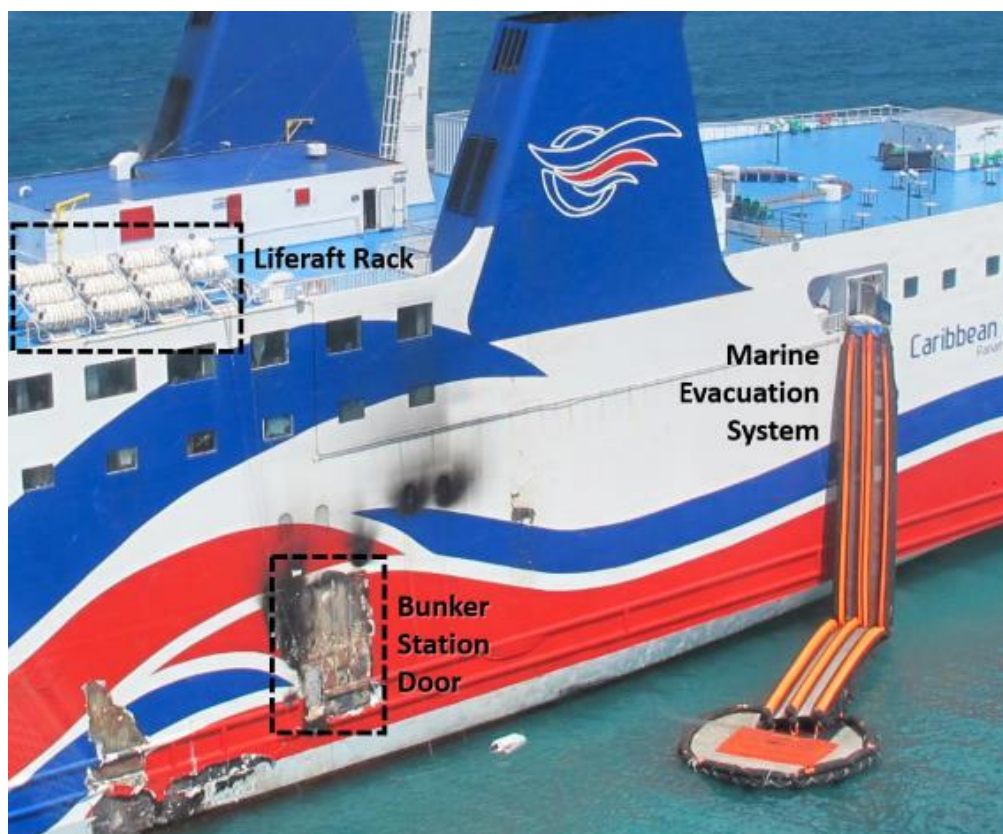
Figure 7-3 Situation of the portside MES (Ministry of Infrastructure and Transport, Final Report)

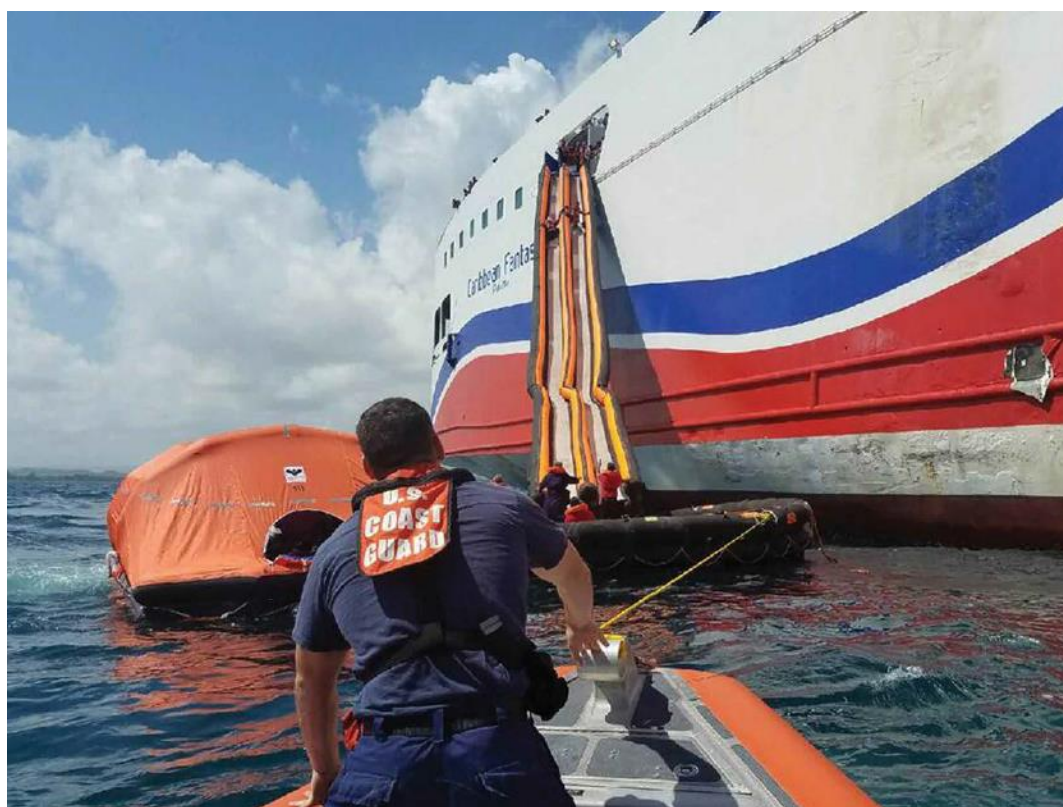
Figure 7-4 Coast Guard vessel assisted with towing the MES (Warren, Winter 2020)

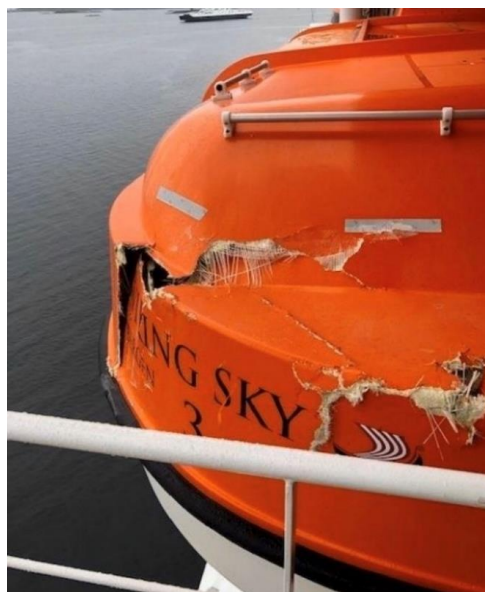
Viking Sky had four lifeboats for 235 persons each, two lifeboats for 150 persons each and in addition 19 liferafts for 35 persons each which give a total capacity for the lifeboats/-rafts of 1,905 persons, equally distributed on each side (Norwegian Safety Investigation Authority, March 2024). The lifeboats were not lowered, as lifeboats were not considered a safe means of evacuation in such rough weather close to shore. Lifeboat No. 3 (standard size lifeboat, positioned on starboard, 2<sup>nd</sup> from bow) and all LB davit control stations and lifejacket boxes on starboard side have been damaged by wave impact.

Figure 8-2 Damage to LB3 (Norwegian Safety Investigation Authority, March 2024)
