# CMS IN SUPPORT OF ICELANDIC COAST GUARD FUNCTIONS

CMS User Group Meeting  
9 October 2018

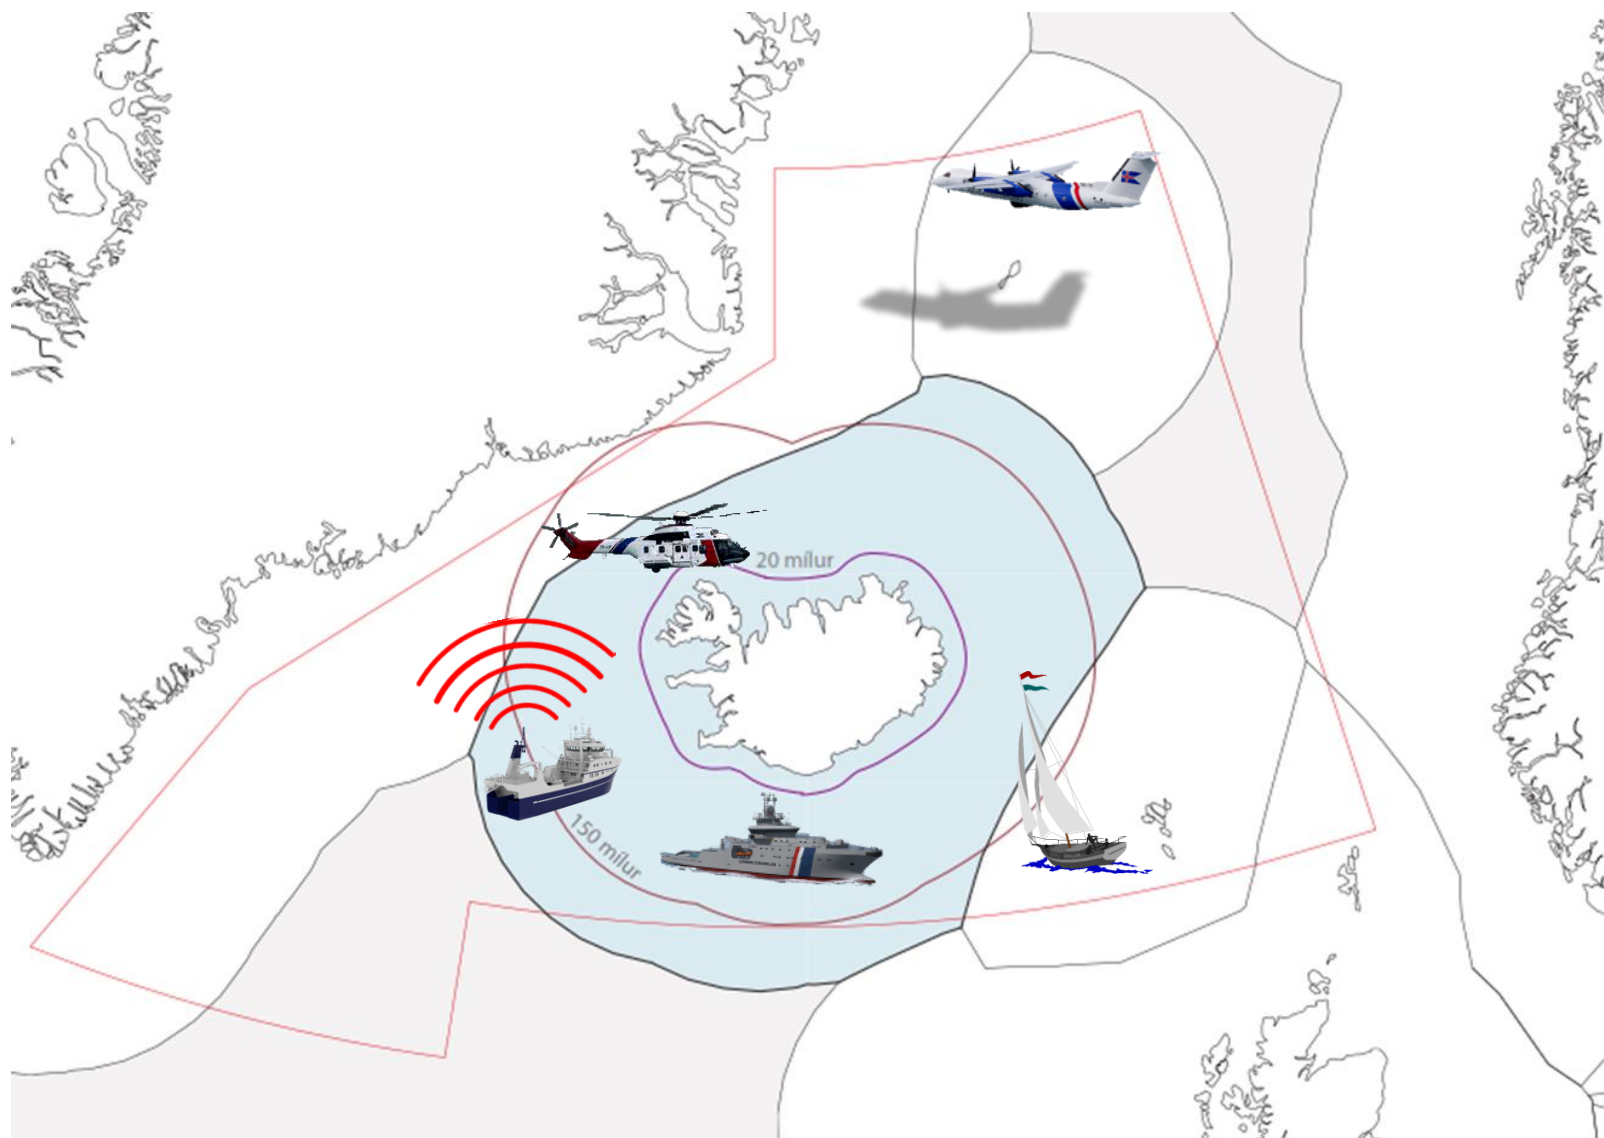
# AREA OF RESPONSIBILITY

## **TERRITORIAL WATERS:**

12 nautical miles

## **EXCLUSIVE ECONOMIC ZONE:**

200 nautical miles

## **SEARCH & RESCUE REGION**

### **ICELAND SRR:**

1.9 million km<sup>2</sup>

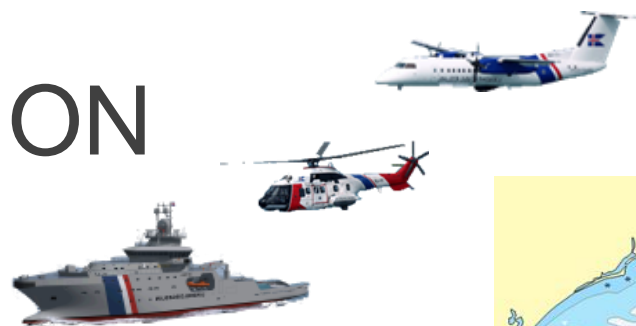
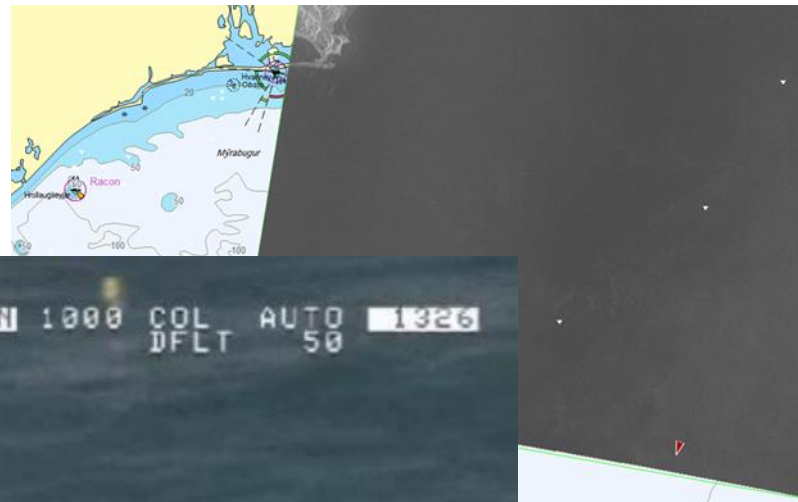
## Image

August 24

Service: IMS\_Customs

Sensor resolution: small boats

## Uncorrelated target

Estimated length 31 m

Confidence level 75%

## In situ detection

Dead whale found

Danger to ships traffic

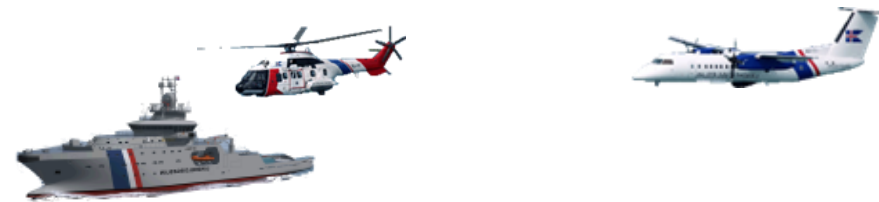
## Image

June 1

Service: IMS\_Fisheries

RADARSAT-2

Sensor resolution: medium size vessels

## Value added product

Uncorrelated target

Estimated length 63 m

Confidence level 100%

Surveillance a/c diverted

In situ detection

Foreign state fishery survey vessel

Actual length 76 m

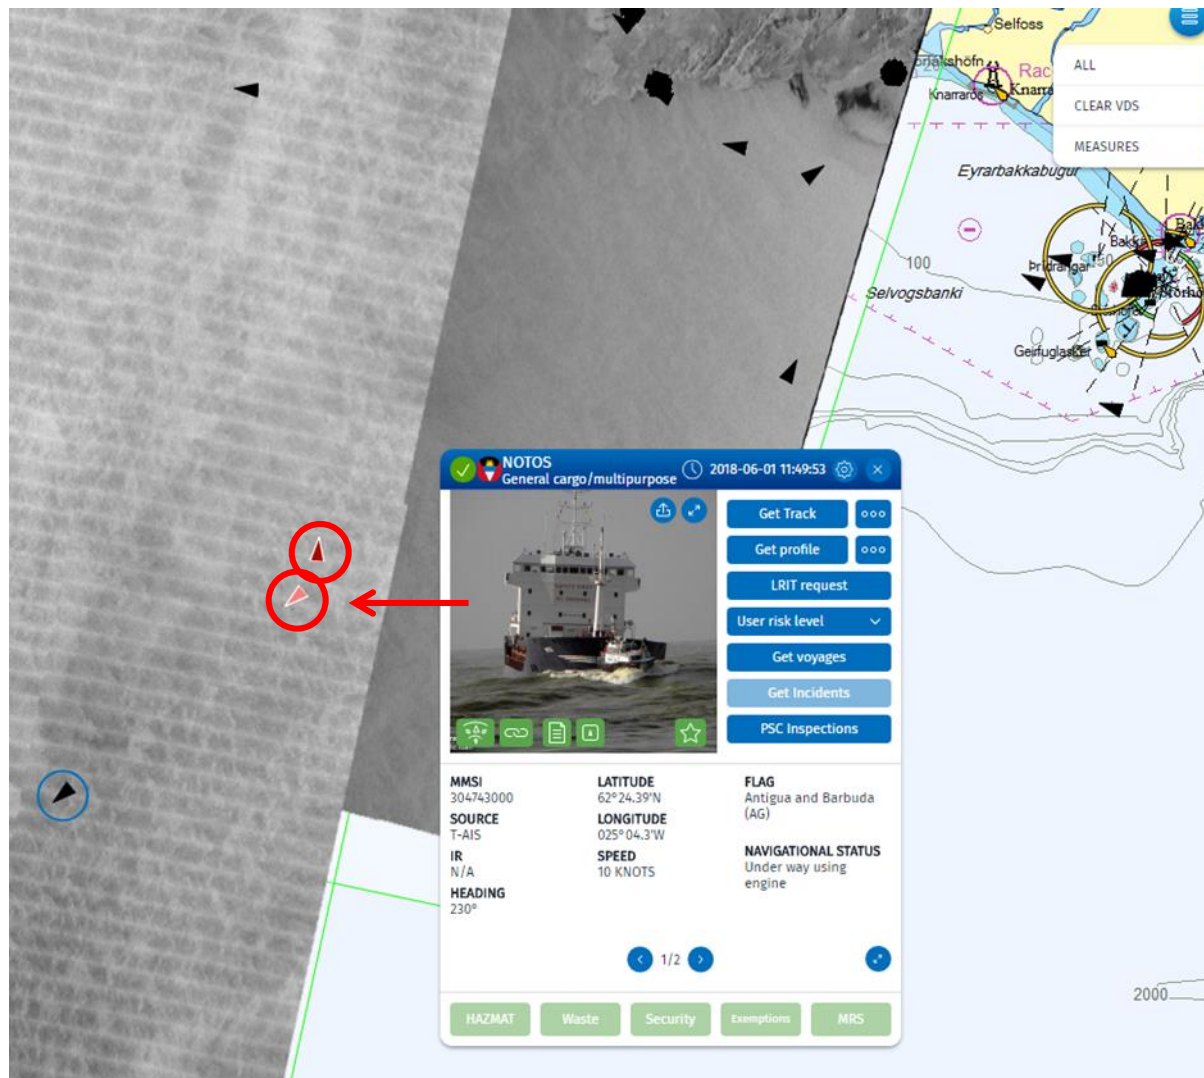
## Images

September 10

Service: IMS\_LAW and CLEANSEANET

Satellites: RADARSAT and SENTINEL

Sensor resolution: medium

## Uncorrelated targets

Estimated length 100 - 170 m

Confidence level 30% - 100%

## Icebergs

Cost-effective way to detect  
icebergs being a hazard to navigation

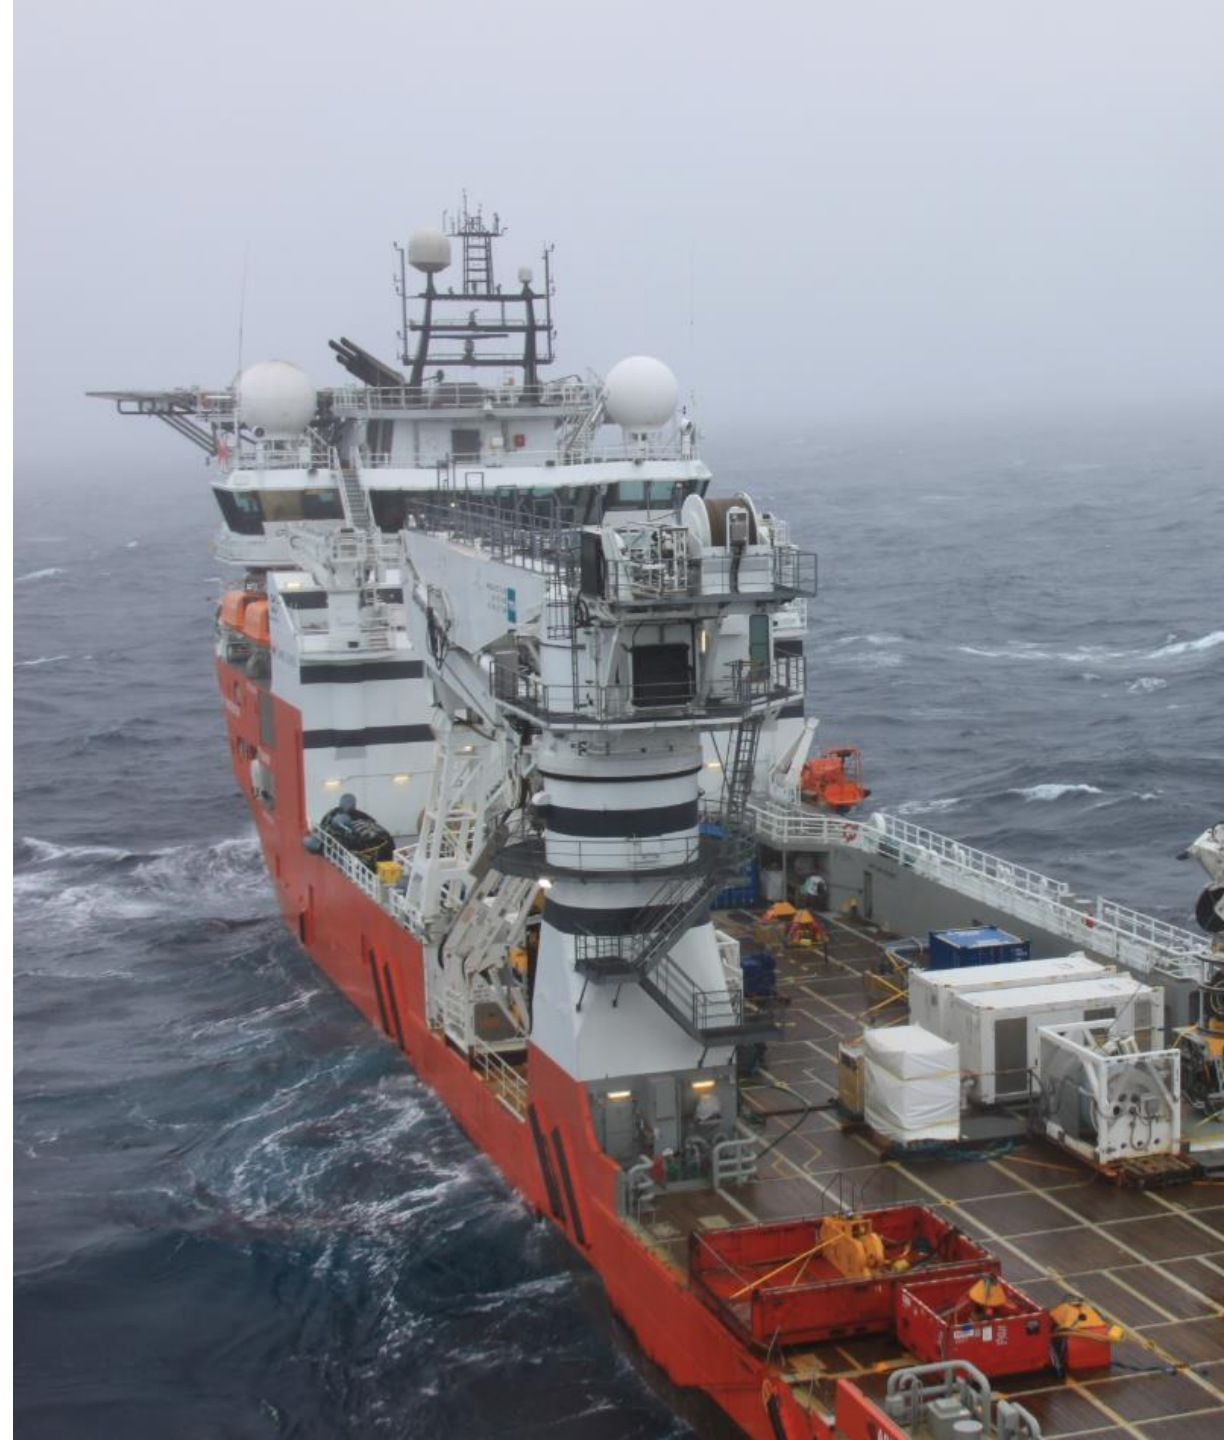
- Multi-Purpose Offshore Construction Vessel searching for valuable minerals in the WWII merchant vessel „Minden“ in 2017
- A permit for marine research was not applied for until its operation had been investigated by the coast guard.

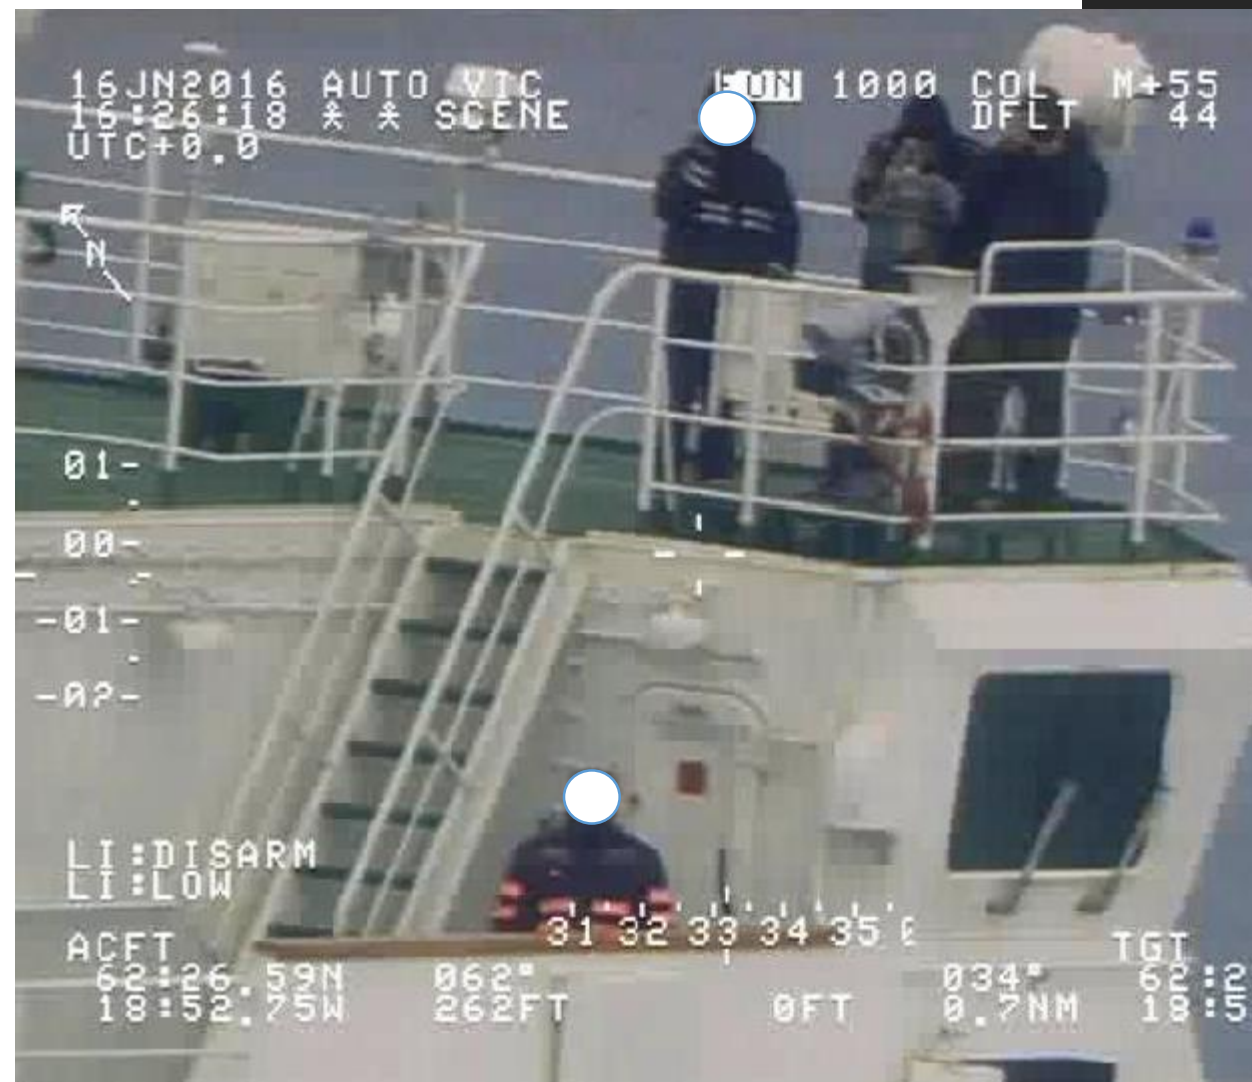
- June 2016 – ICG MSA spots the Russian research vessel Yantar south of Iceland.
- Operated by the Russian Navy.
- Operates down to 6000 m.

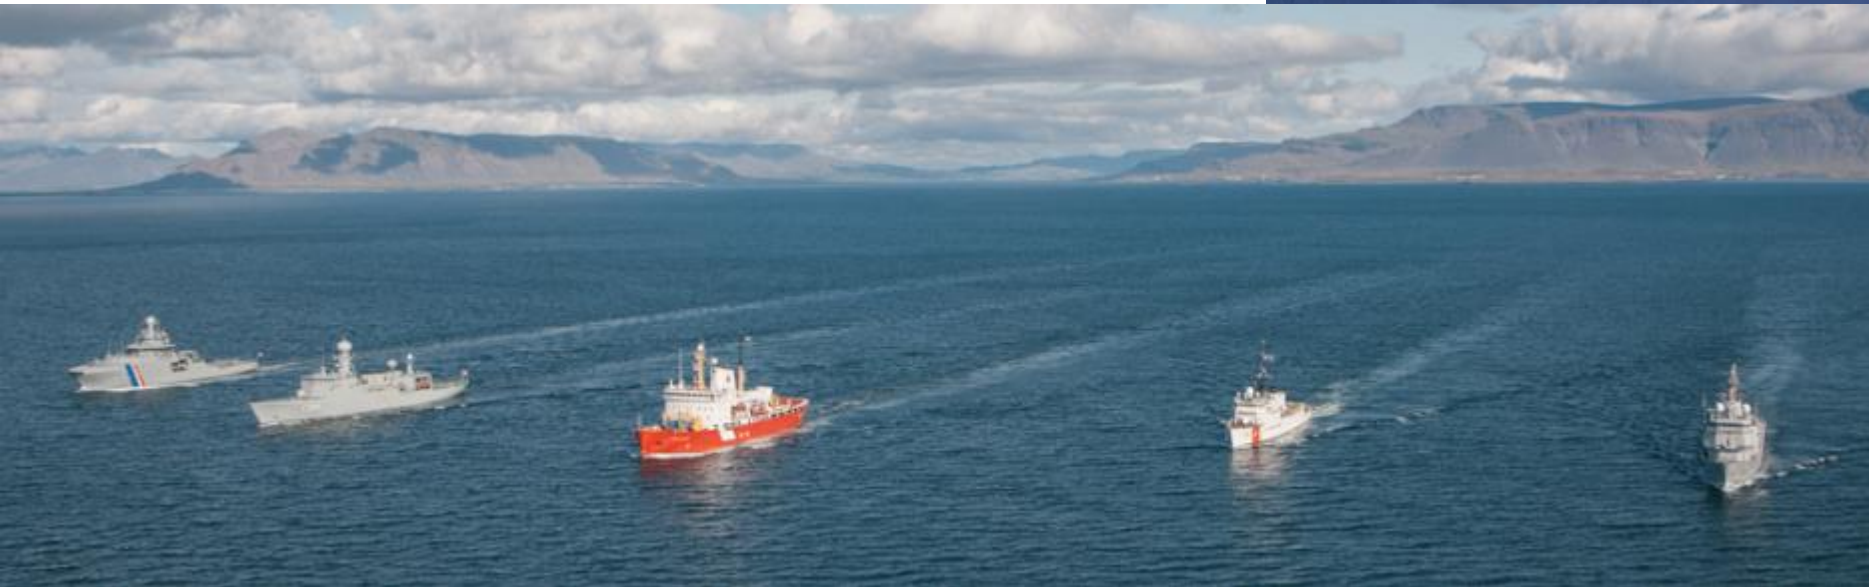
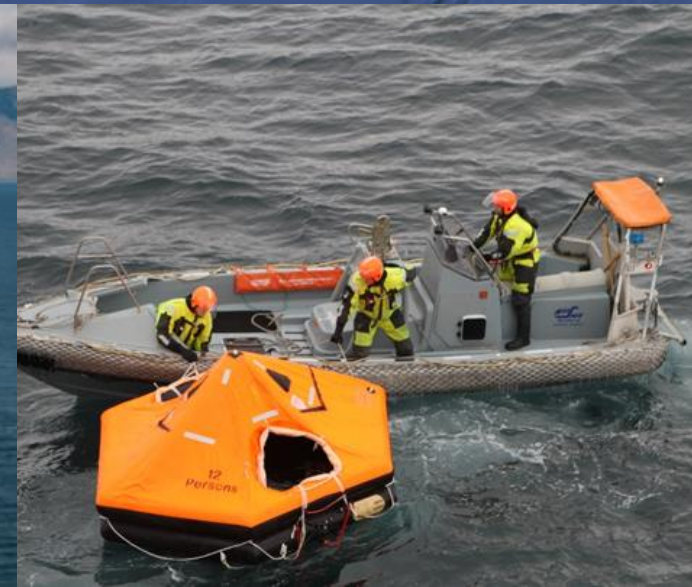
In support of search operation during ACGF exercise “Arctic Guardian”

- Resolution <1m
- Short notice
- Life-raft search
- Cancelled due to cloud cover

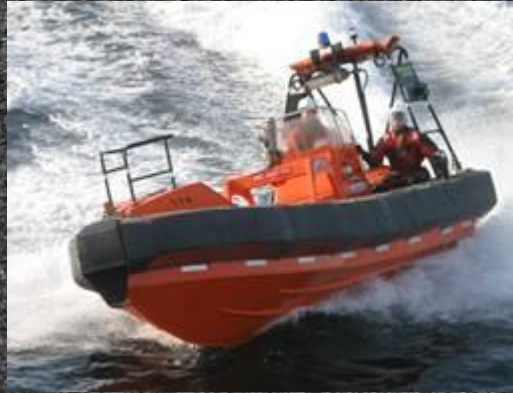
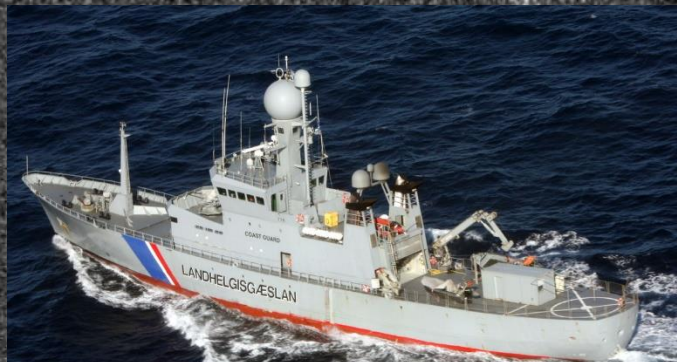
July 2018

Test of the IMS\_CUSTOMS  
image

(sensor resolution 7,7 m)

FRB with length of 8 m, was  
not detected

FALSE NEGATIVE?

2018-07-31 07:12:35

Satellite: RADARSAT-2
