DETECTING MARINE POLLUTION FROM SPACE

## CLEANSEANET SERVICE OVERVIEW

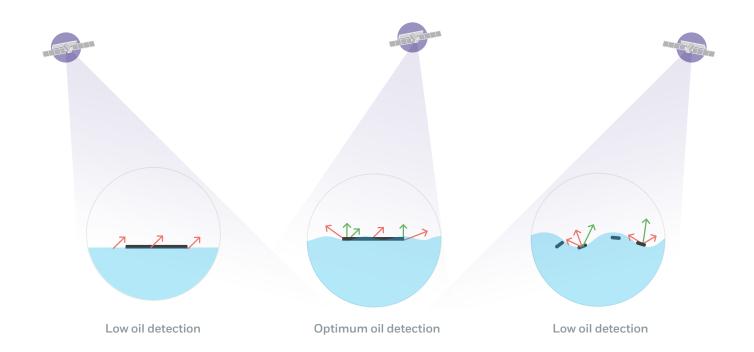
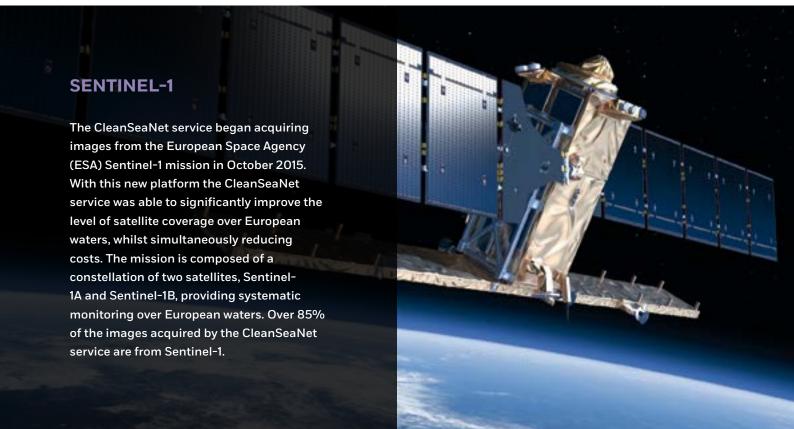
CleanSeaNet monitoring is possible through the use of SAR and optical images. SAR images are the result of electromagnetic pulses generated by a radar, that are reflected by the ocean surface. By measuring the roughness of the sea surface, resulting images display features which stand out against the background; for example, vessels appear as bright spots, while oil spills appear as dark shapes. Images can be acquired regardless of weather conditions and cloud cover, and at any time of day or night.

Optical sensors include visible, near infrared and short-wave infrared wavelengths, producing images that are similar to the way in which the human eye sees the world.

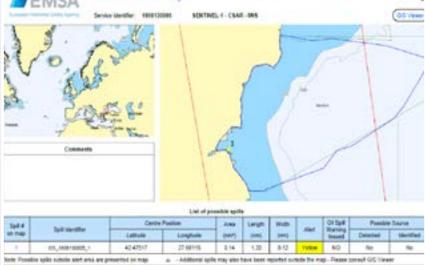
## OIL LEAK FROM WRECK

On 12 August 2018, oil was reported on the beaches of Sozopol and Chernomorets, on the Bulgarian coast. The following day, a routine SAR image from the CleanSeaNet service detected a possible oil spill in the area, above the location of a known wreck.

The spill was confirmed on site, and samples identified the substance as heavy fuel oil leaking from the wreck of the vessel M/V Mopang, which had sunk in 1921, two nautical miles off the port of Sozopol.

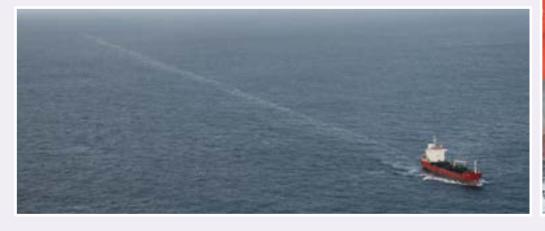
## POLLUTER CAUGHT RED-HANDED

A Netherlands Coast Guard aircraft was immediately dispatched to the location, and the source of the pollution was identified as a chemical tanker performing a tank washing operation.

Pictures taken from the aircraft showed residues being  $% \left( x_{0}\right) =\left( x_{0}\right) +\left( x_{0}\right) =\left( x_{0}\right) +\left( x_{0$

discharged via a hose above the waterline and a second one below the waterline. The shipmaster was contacted and confirmed that tank washing of palm oil was taking place, and that this was in accordance with the relevant regulations.
