**S 590a / 09**

**Damage Stability Tests with the  
Model of an 80 m RoPax Vessel**

**Final Report Part IIa**

**Customer:  
European Maritime Safety Agency (EMSA)**

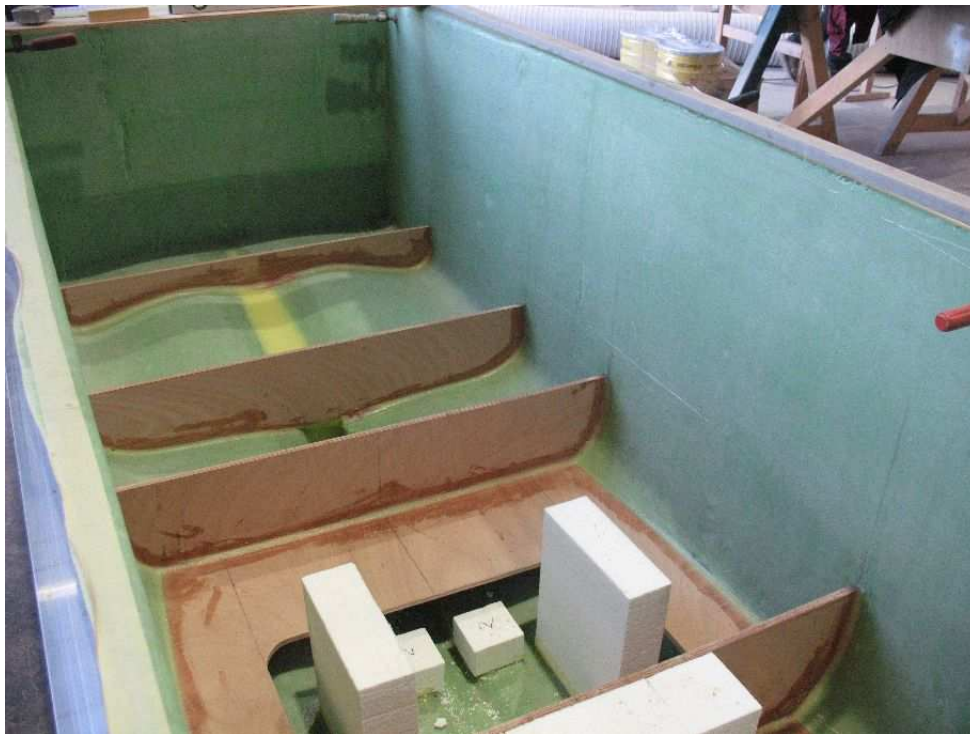
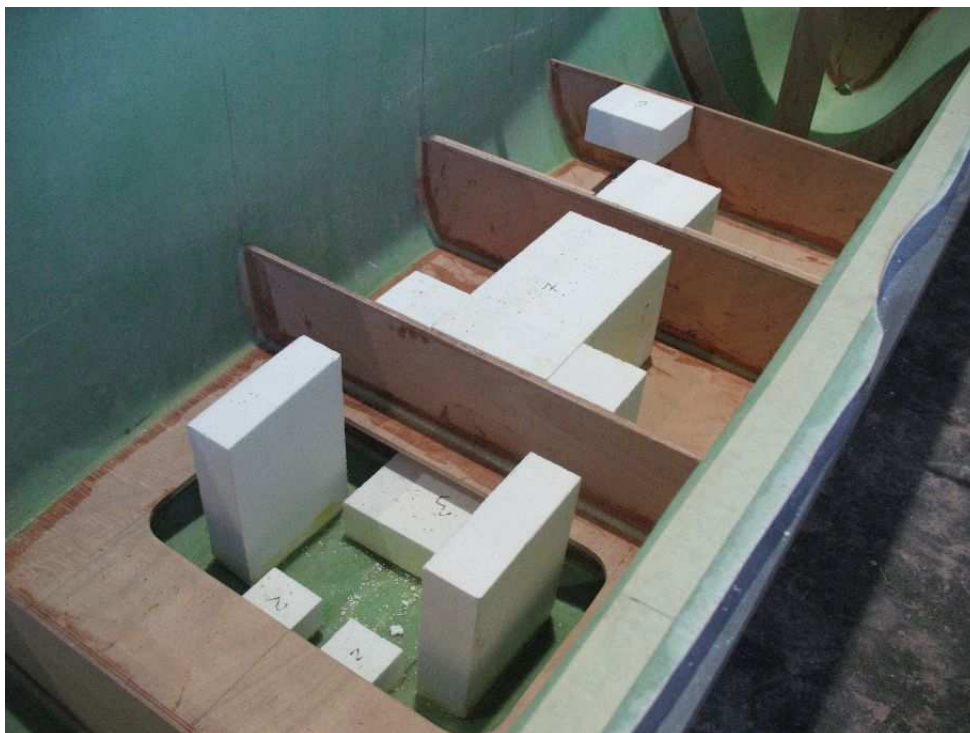
Figure 11: Model manufacture

For the tests one model with an overall length of 5 m and a hull thickness of 4 mm has been built including all relevant internals and structural details. The tests were carried out in HSVA's large towing tank on 23<sup>rd</sup> and 24<sup>th</sup> February 2009. The free drifting model was positioned in long-crested irregular beam seas (90° encounter angle) with the damage hole facing the incoming waves. Two damage cases have been considered within the model tests of which the first extended over one compartment whereas the second damage hole involved two compartments.

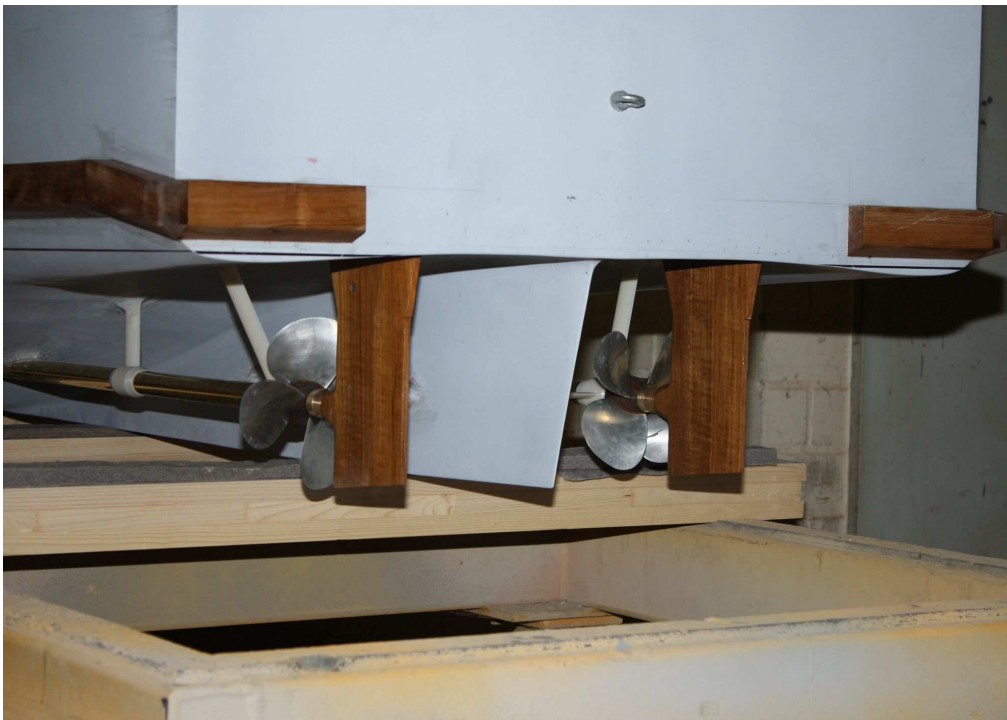
**Figure 12: Rudder and propeller arrangement**

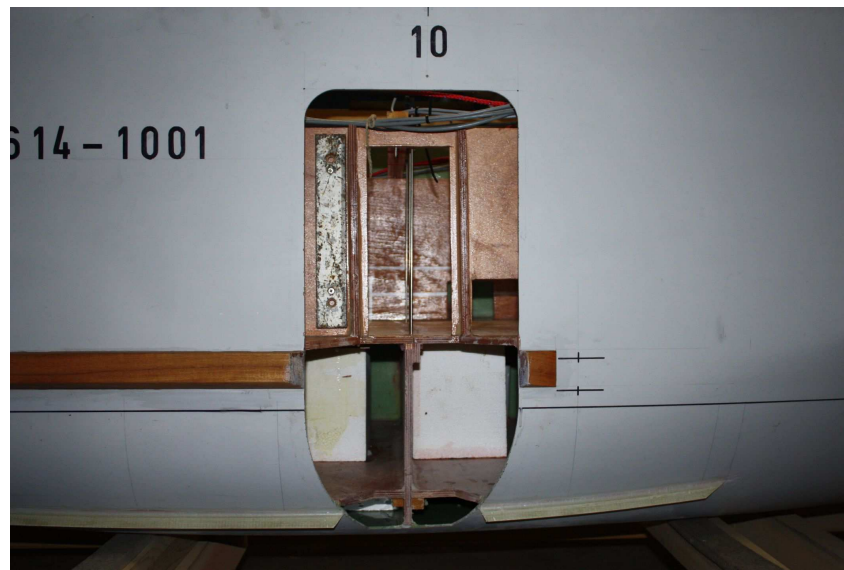
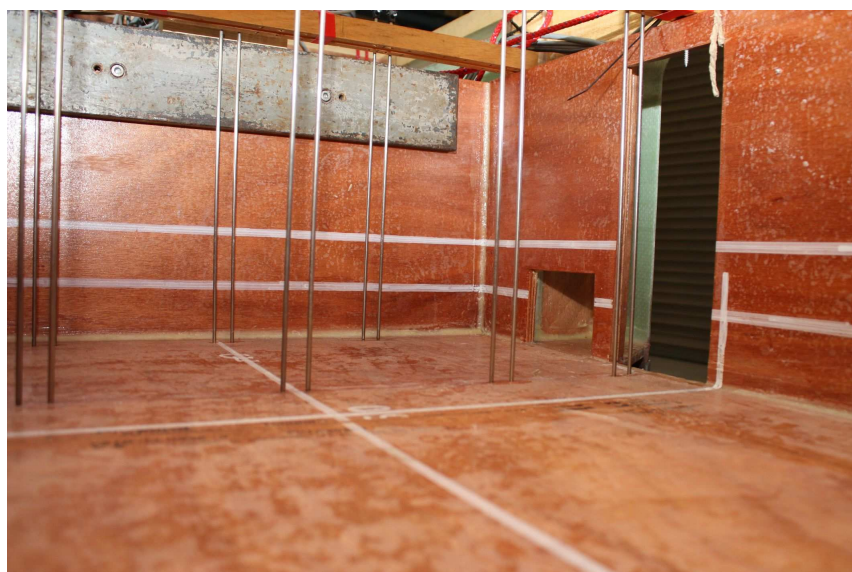
**Figure 14: Leakage of Damage Case 4**

The second damage (Damage Case 4) had the same extensions as the first damage, but was located on starboard side with its longitudinal centre at 36.40 m in front of the aft perpendicular. In addition to the car deck this leakage involved two compartments of the double bottom (Void Spaces 6 and 5) and two compartments above the tank top (Pump Room/Main Switchboard and Sewage Plant/AC Chillers Room/Engine Control Room).

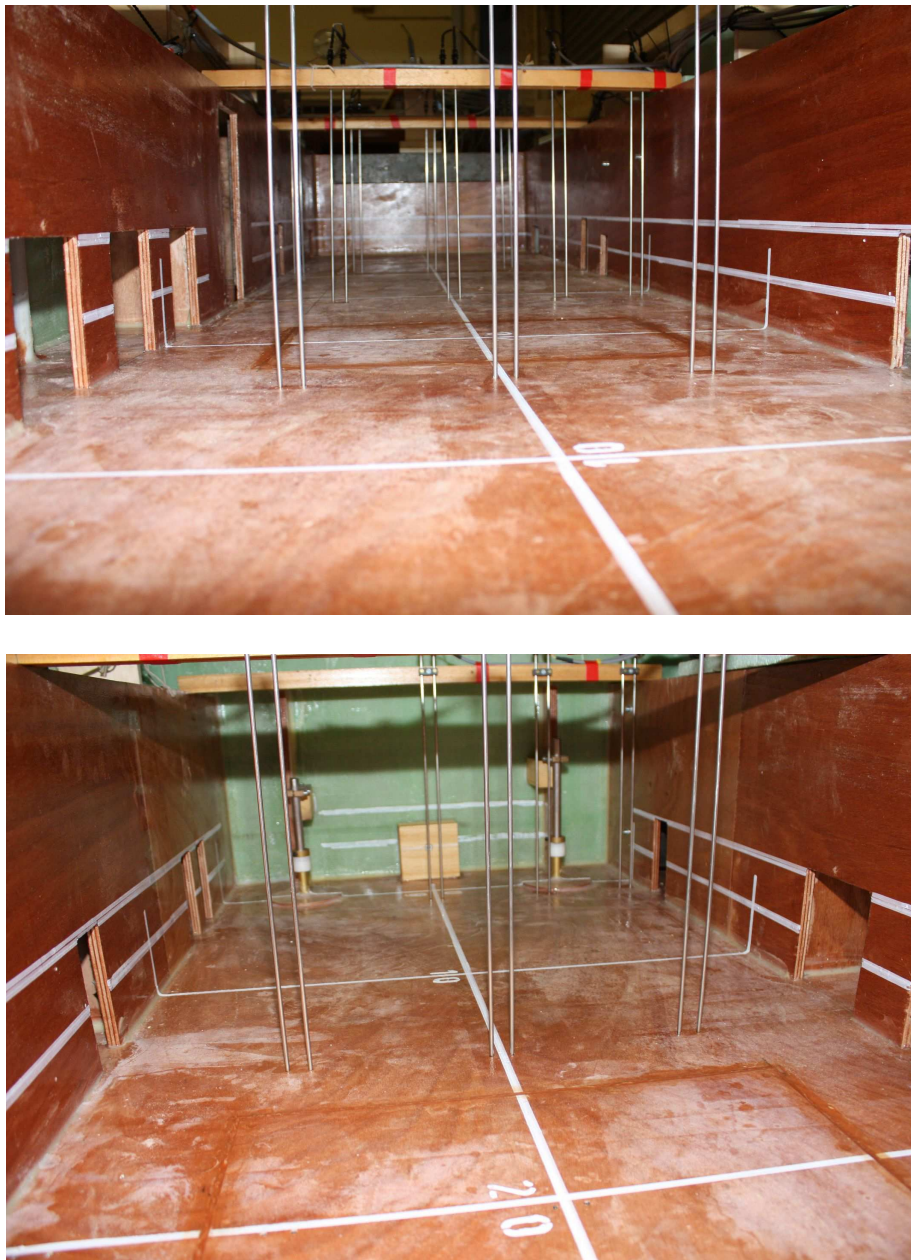
**Figure 15: Wave probes inside the hold**

Fourteen wave probes have been arranged in order to determine the water level in the relevant areas of the car deck. One further wave probe measured the water elevation directly in front of the hull opening. The positions of the wave probes can be seen in Figure 9 in Annex A.
