**Network of Stand-by
Oil Spill Response Vessels:
Drills and Exercises**

Annual Report 2012

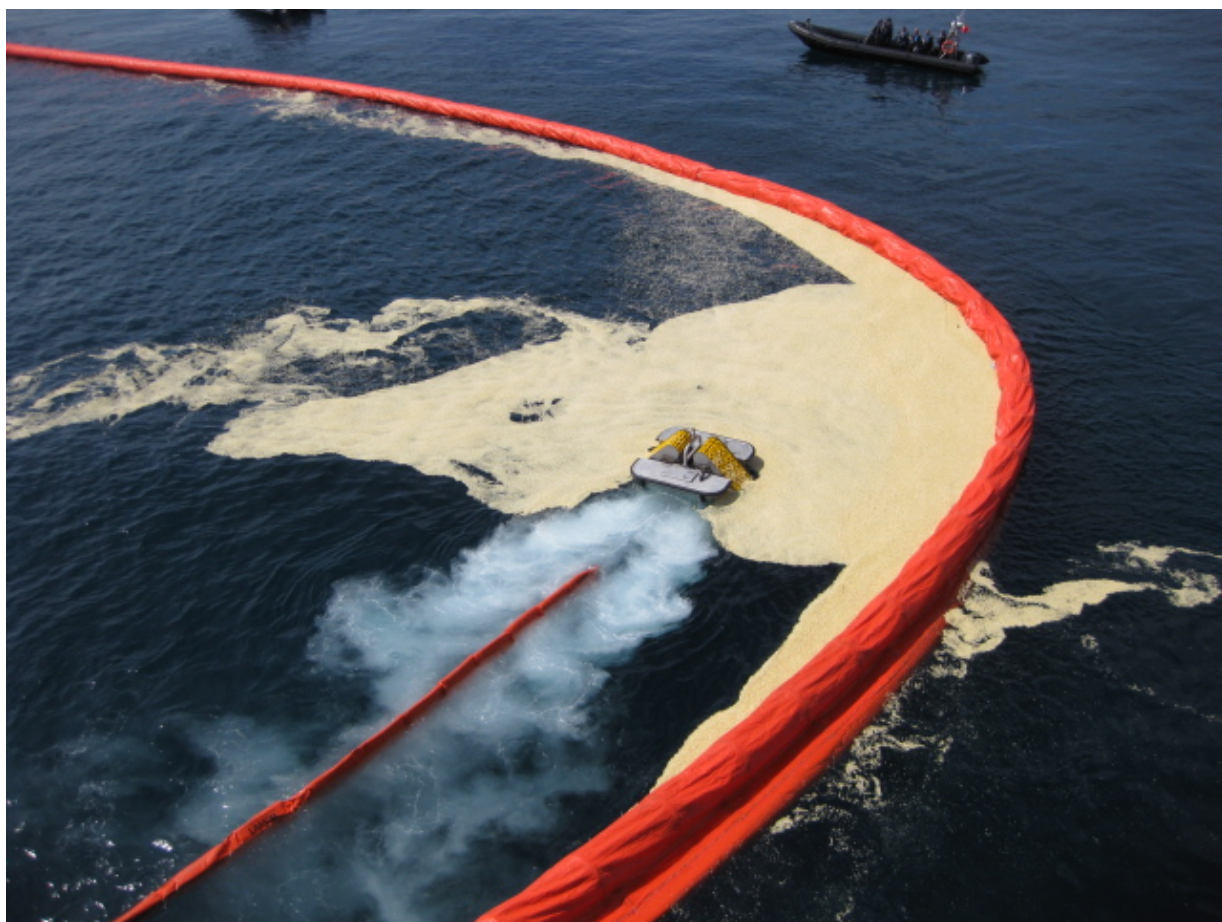
The exercise scenario simulated the collision between two merchant ships in the vicinity of the Port of Sesimbra. As a result of the accident, one of the vessels was adrift, with significant damage to her hull. A spillage of about 900 tonnes of intermediate fuel oil (IFO) 180 and 20 tonnes of lubricants occurred. Following the activation of the relevant Portuguese Contingency Plan and request for assistance to MIC/EMSA, appropriate oil recovery operations were undertaken as well as a shoreline clean-up.

Simulation of oil recovery with skimmer

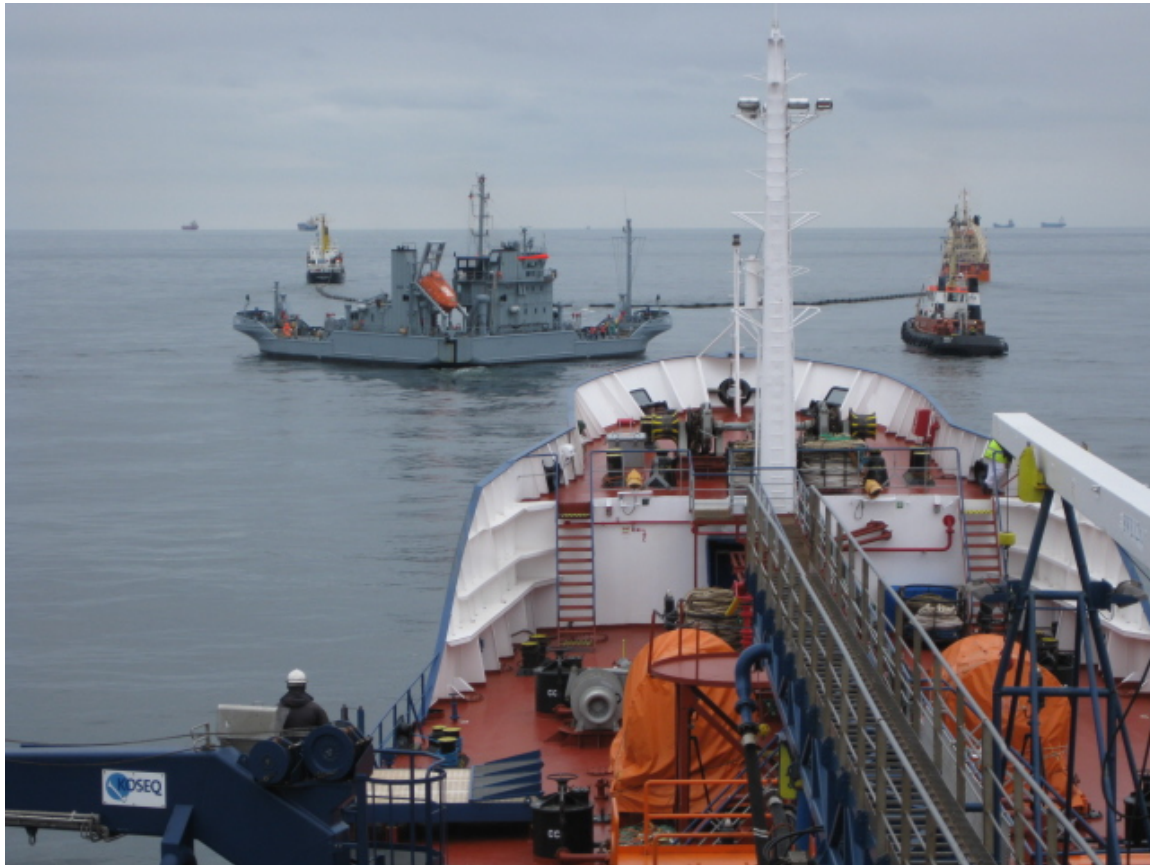
Eversand and *Sara* following the open U formation

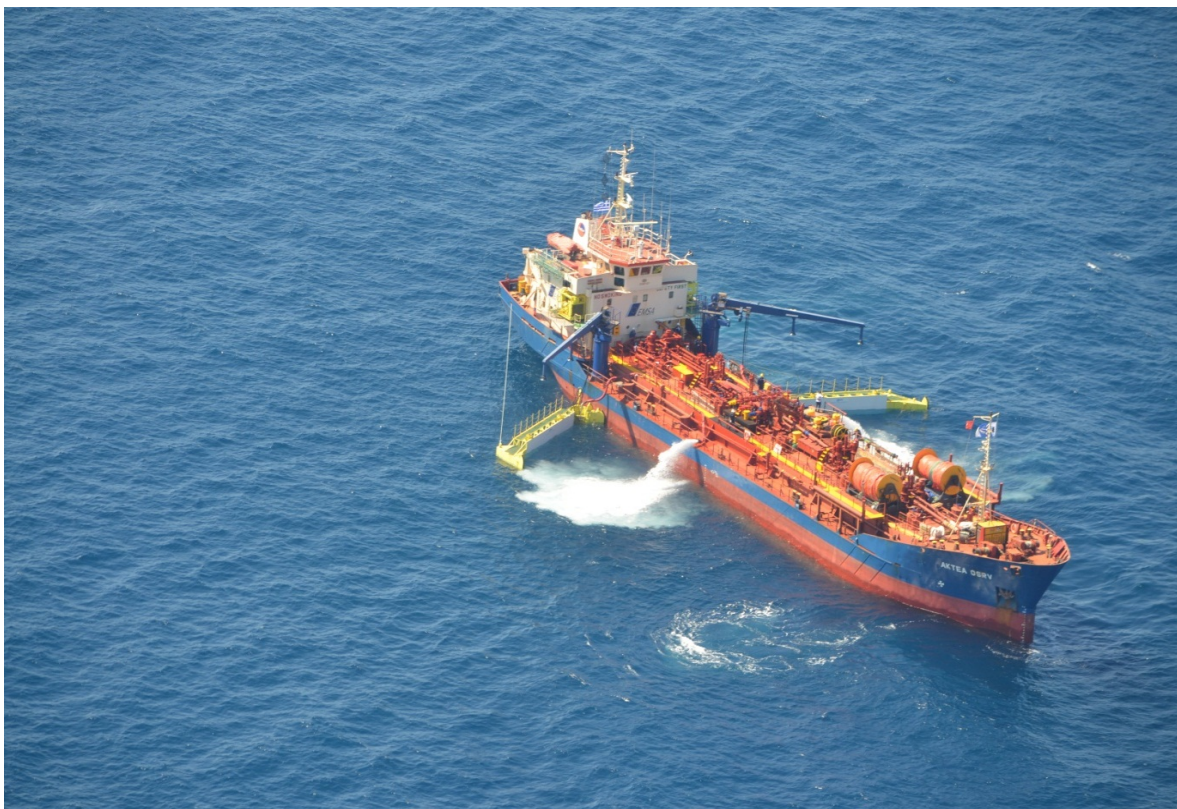
The *Aktea* OSRV with the sweeping arms deployed during Nireas 2012 exercise

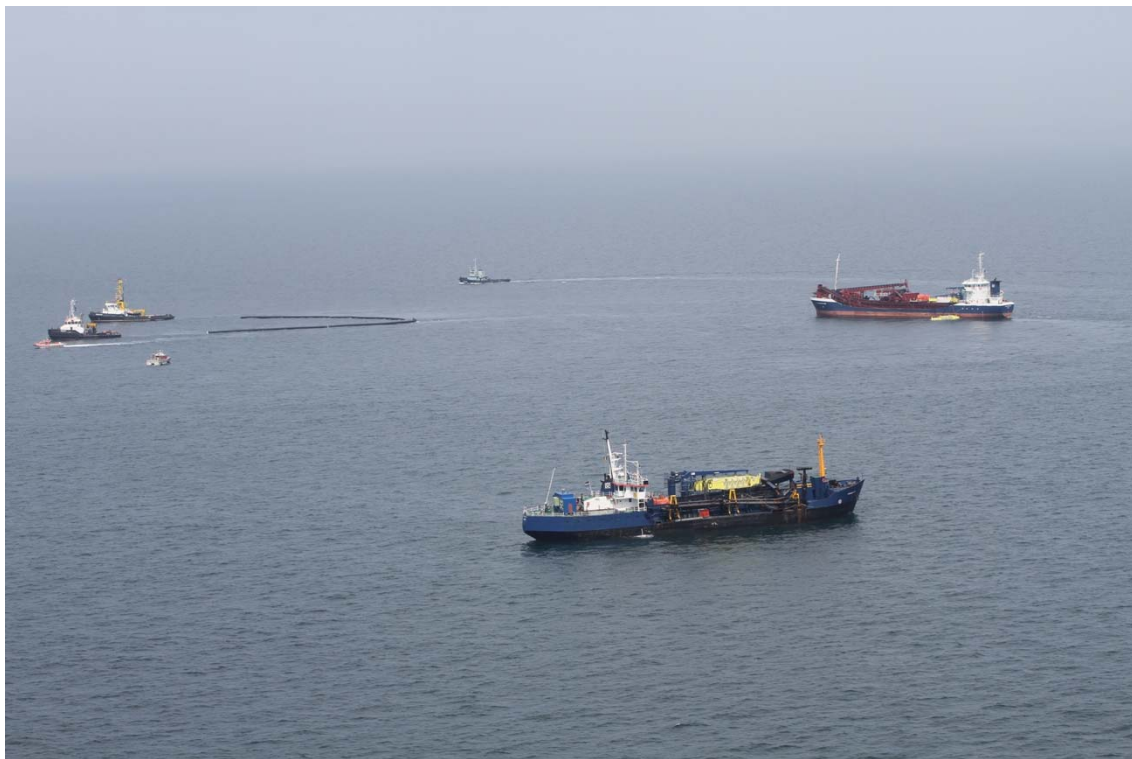
In general, the exercise programme included testing the "U" formation of the boom towed by the Belgian tugs and followed by the *DC Vlaanderen*, *Interballast III* and *Arca* skimming oil with their sweeping arms. The exercise was coordinated by the Belgian On-scene Commander. The exercise programme was completed successfully.

DC Vlaanderen 3000 and Interballast III following the "U" formation

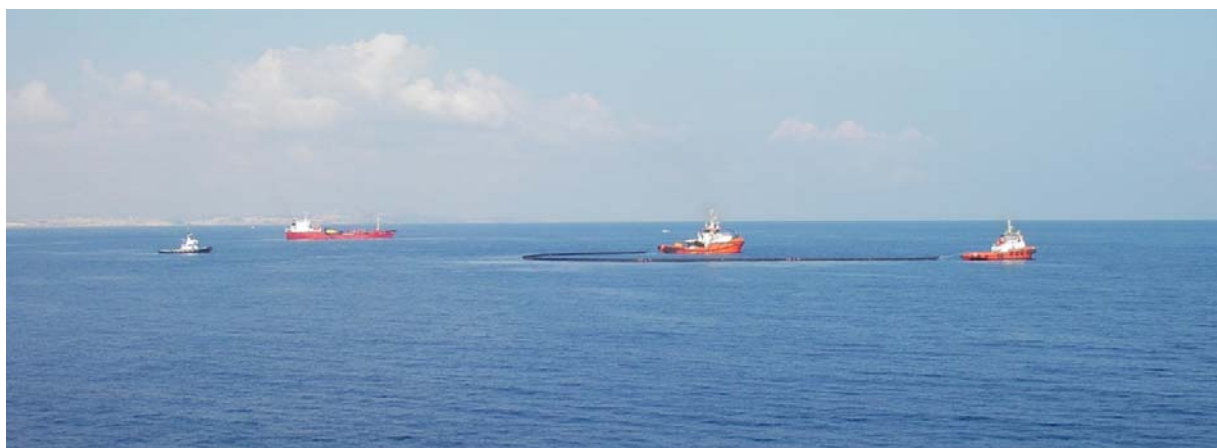
The *Spinola* and the *Felica* (two Maltese tugboats) deployed 250 m of containment booms in a J-formation, and the *Spinola's* skimmer was deployed.

The tugs *Spinola* and the *Felica* deploying a boom in J-formation

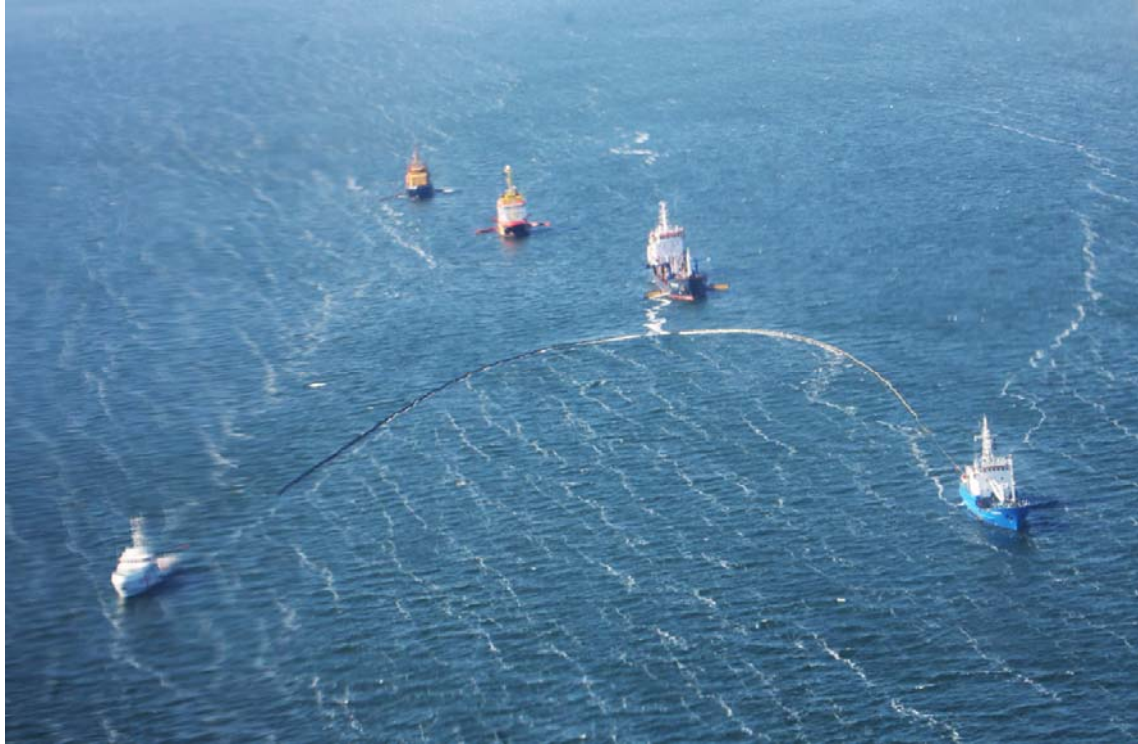
The exercise scenario was realistic and the manoeuvring of the *OW Copenhagen* with sweeping arms deployed behind the Open-U boom configuration was successfully conducted.

Exercise POLGER 2012 - Open U formation followed by *OW Copenhagen, Scharhörn and Kapitan Poinc*

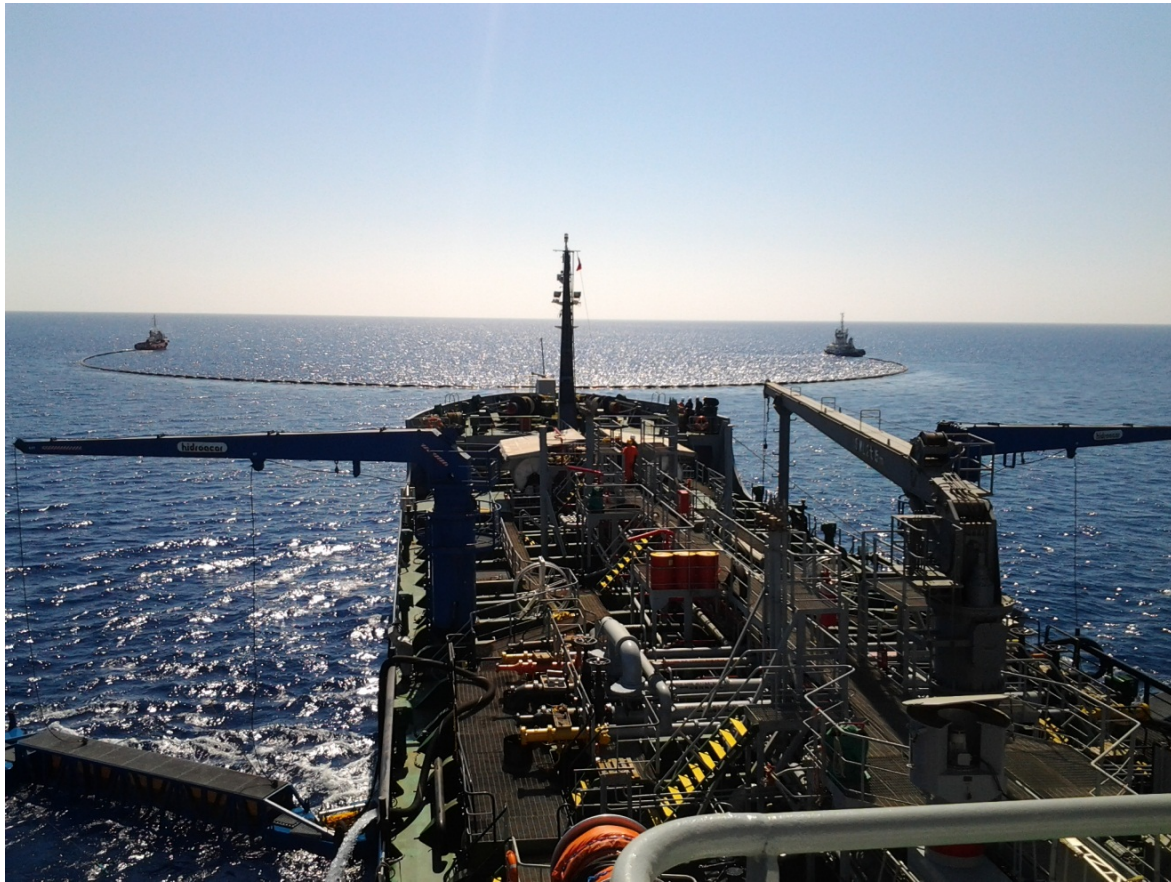
***Alexandria* following a boom open U-formation with sweeping arms deployed**

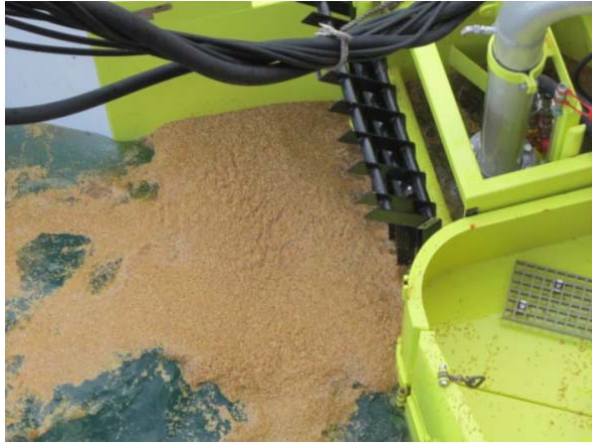
Popcorn simulating oil
