# EMSA study

## EMSA/2024/OP/0014

### Lessons learned from passenger ship accidents

Date: 2025-03-29

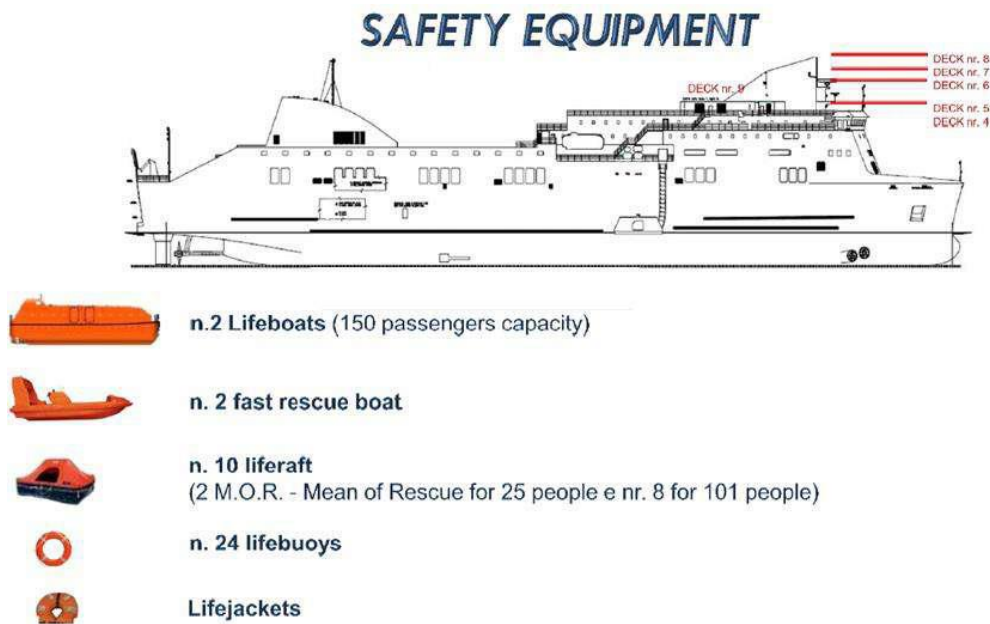
Figure 6-2 Safety Equipments onboard the Norman Atlantic

1. To prohibit open Ro-Ro cargo spaces on new passenger ship designs. The rapid spread of fire due to the high wind and open spaces was a significant contributing factor for the severity of the incident.
2. Need to enhance the passive fire protection of the LSA from fire. The LSA around garage openings were severely damaged rendering it unfit for the intended use of these critical safety devices during such a emergency.
